AS2870-2011 SITE ASSESSMENT

328 Lune River Road

Ida Bay

September 2020

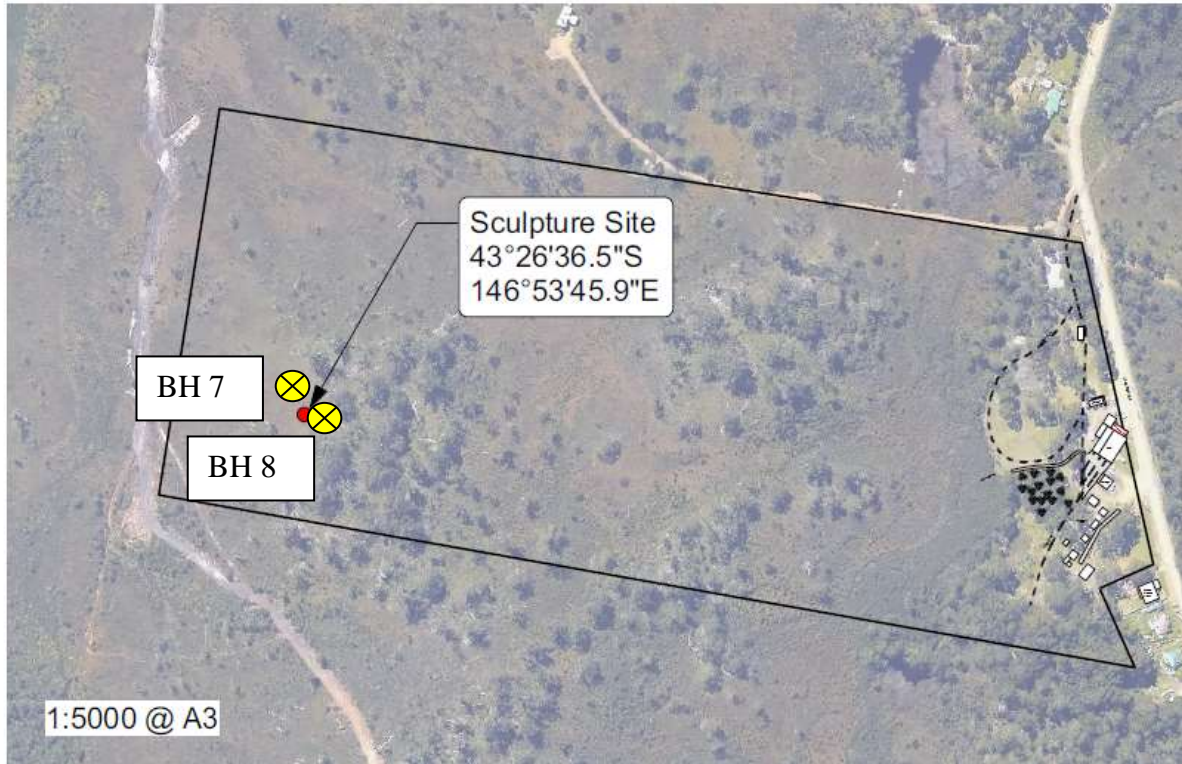
Site Plans

A number of excavations were completed to identify the distribution of, and variation in soil materials on the site. Representative excavations from various construction areas indicated on the site plan were chosen for testing and classification according to AS2870-2011 (see profile summaries).
