Department of State Growth
Arthur Highway - Eaglehawk Neck Safety Upgrade Project
Coastal Geomorphology Assessment

July 2021

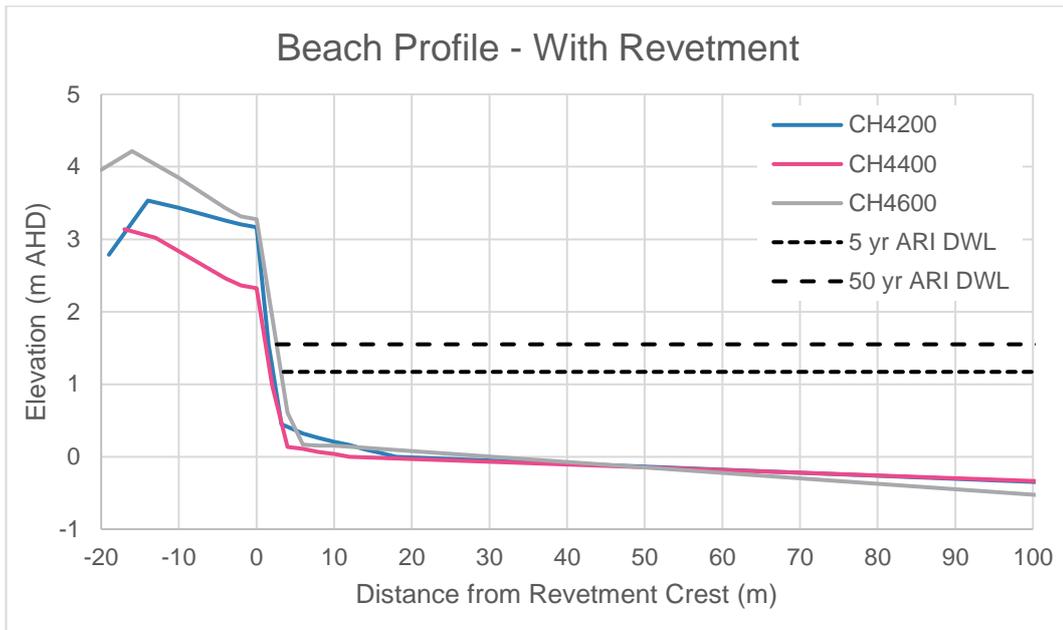
Figure 1 Beach profiles at the three chainages, with the rock revetment

Figure 1 and Figure 2 show the initial profiles at the three chainages with and without the revetment (i.e., present-day condition). In these figures, 0 m in the x-axis is defined as the baseline of the profiles, which is the seaward edge of the revetment crest.

The beach profiles at CH4200, CH4400, and CH4600^[2] took into account the available topography survey, publicly available bathymetry data, and the design profile of the proposed highway widening.

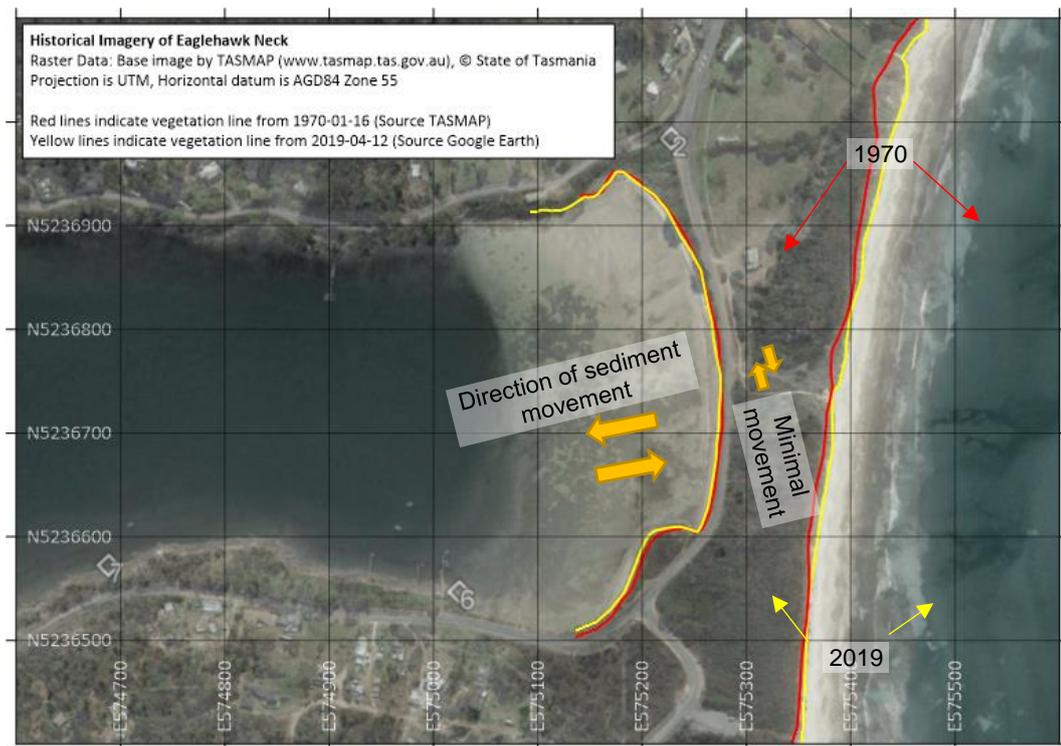
Figure 3 Overlay of 2019 (50% transparency) and 1970 images including shorelines

Table 2 summarises the aerial images reviewed. Observations on the images indicate that:

- The vegetation line of the project site has been relatively stable. A recession rate was not estimated given the stability of the shoreline. An estimate of the recession rate would likely be incorrect and any rate obtained, would most likely be from an error associated with georeferencing the images

- The width of visible dry beach varies; however, this is most likely due to variation in water levels when the photos were taken. The changes could also be caused by seasonal changes.

- There is no prominent trend of longshore sediment transport and shoreline movement along the project site and the adjacent shoreline. The sediment transport pattern, if any, appears to be in a cross-shore direction (on/offshore)

Overall, longshore sediment along the beach is expected to be insignificant and possibly negligible. This is generally deductable from the narrow fetch and uni-directional wave climate but also confirmed through review of aerial images demonstrating that beach width at the northern and southern extremities of the foreshore have been stable over the years.

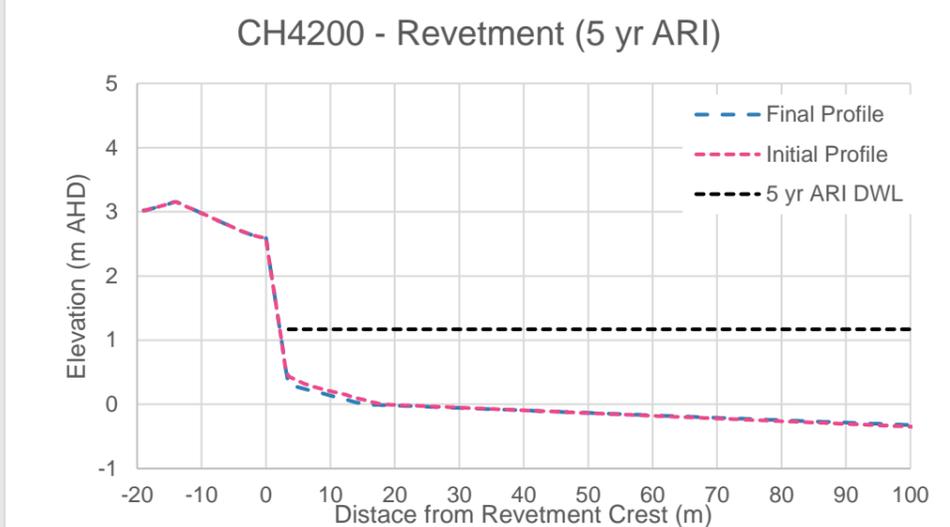
<p>CH4200 - Revetment (5 yr ARI)</p> <p>This graph shows the beach profile with revetment for a 5-year ARI. The y-axis is Elevation (m AHD) from -1 to 5, and the x-axis is Distance from Revetment Crest (m) from -20 to 100. It includes three lines: Final Profile (blue dashed), Initial Profile (red dashed), and 5 yr ARI DWL (black dashed). The DWL is constant at approximately 1.2 m. The initial profile shows a beach crest at ~3.2 m elevation, which drops to ~0.5 m at the revetment crest (0 m). The final profile shows a similar drop but with a slightly lower crest and a steeper slope.</p>

- During the 5 yr ARI event, the model estimated recession of the present-day highway batter slope above the design water level, with the sediment being deposited below the design water level. This erosion is expected as the wave impacts the batter slope and mobilises the sediment, where the sediment is then settled underwater^[3]. With the construction of the proposed revetment, the erosion at the shoreline is seen to have been reduced and or eliminated.

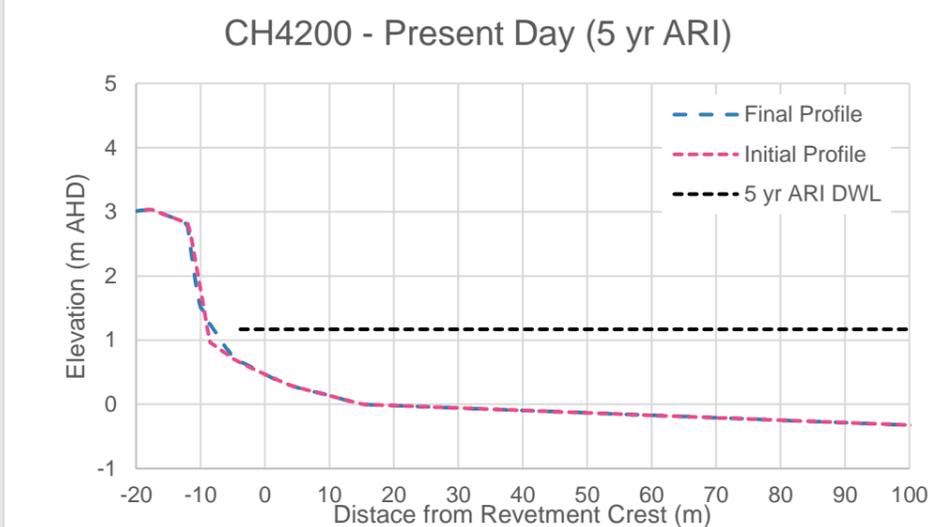
<p>CH4200 - Present Day (5 yr ARI)</p> <p>This graph shows the beach profile without revetment for a 5-year ARI. The axes and legend are the same as the revetment graph. The DWL is constant at approximately 1.2 m. The initial profile shows a beach crest at ~3.2 m elevation, which drops to ~0.5 m at the revetment crest (0 m). The final profile shows a similar drop but with a slightly lower crest and a steeper slope.</p>

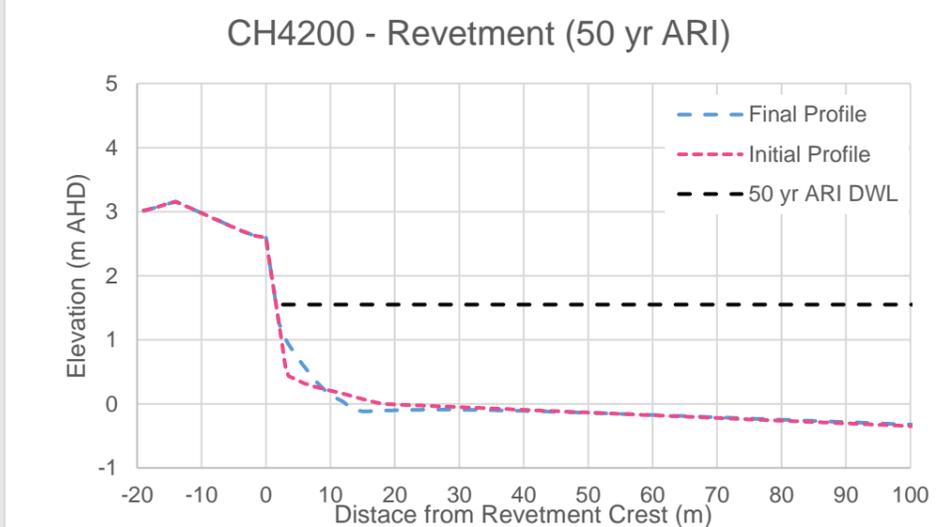
<p>CH4200 - Revetment (50 yr ARI)</p> <p>This graph shows the beach profile with revetment for a 50-year ARI. The axes and legend are the same as the 5-year ARI revetment graph. The DWL is constant at approximately 1.6 m. The initial profile shows a beach crest at ~3.2 m elevation, which drops to ~0.5 m at the revetment crest (0 m). The final profile shows a similar drop but with a slightly lower crest and a steeper slope.</p>

- During the 50 yr ARI event, the model simulated erosion of present-day highway batter slope in the is predicted to occur. With the revetment in place, the model results show loss of sediment from the area immediately seaward of the revetment (beachfront), resulting in an approximate beach lowering of 0.2 m. The lowering of the beach was estimated to occur from approximately 10 m to 30 m from the revetment toe.

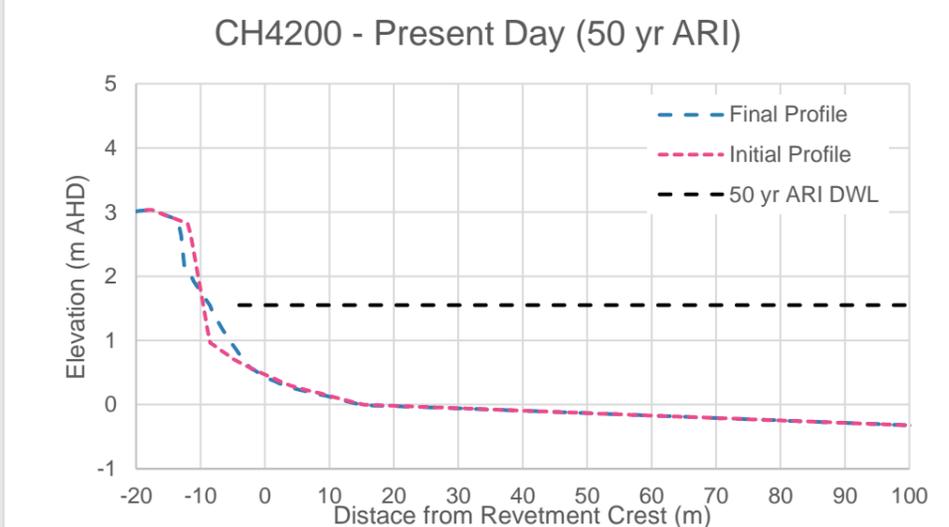
<p>CH4200 - Present Day (50 yr ARI)</p> <p>This graph shows the beach profile without revetment for a 50-year ARI. The axes and legend are the same as the 5-year ARI present day graph. The DWL is constant at approximately 1.6 m. The initial profile shows a beach crest at ~3.2 m elevation, which drops to ~0.5 m at the revetment crest (0 m). The final profile shows a similar drop but with a slightly lower crest and a steeper slope.</p>

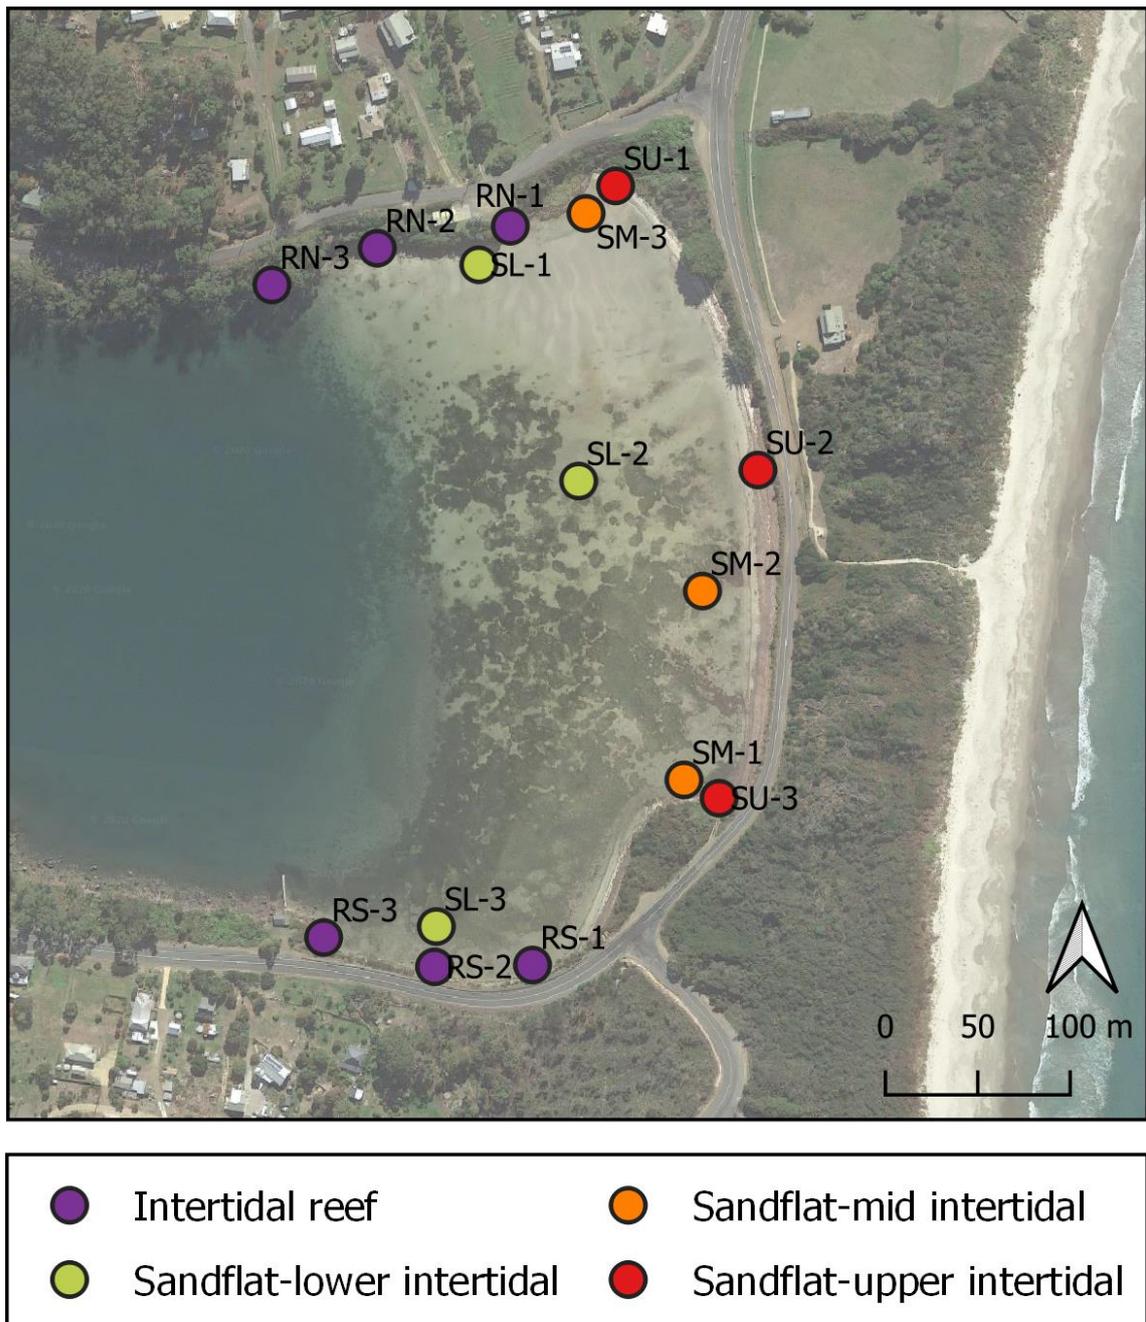
Figure 2 Survey area and location of survey sites. Survey coordinates are included in Appendix 1.

Within each zone, three sites were examined in detail during the field survey (Figure 2). Assessment of intertidal soft sediment habitats involved visual assessment of habitats and surface dwelling biota. Benthic sampling of soft sediments was not undertaken since no benthic fauna of conservation significance were identified in the desktop analysis. Rocky shoreline surveys involved thorough searching of rocky substrates. Rocks were carefully overturned to examine intertidal fauna (e.g. mobile crustaceans, gastropods). Targeted searches for threatened species were not included in the survey design based on the results of the desktop analyses.

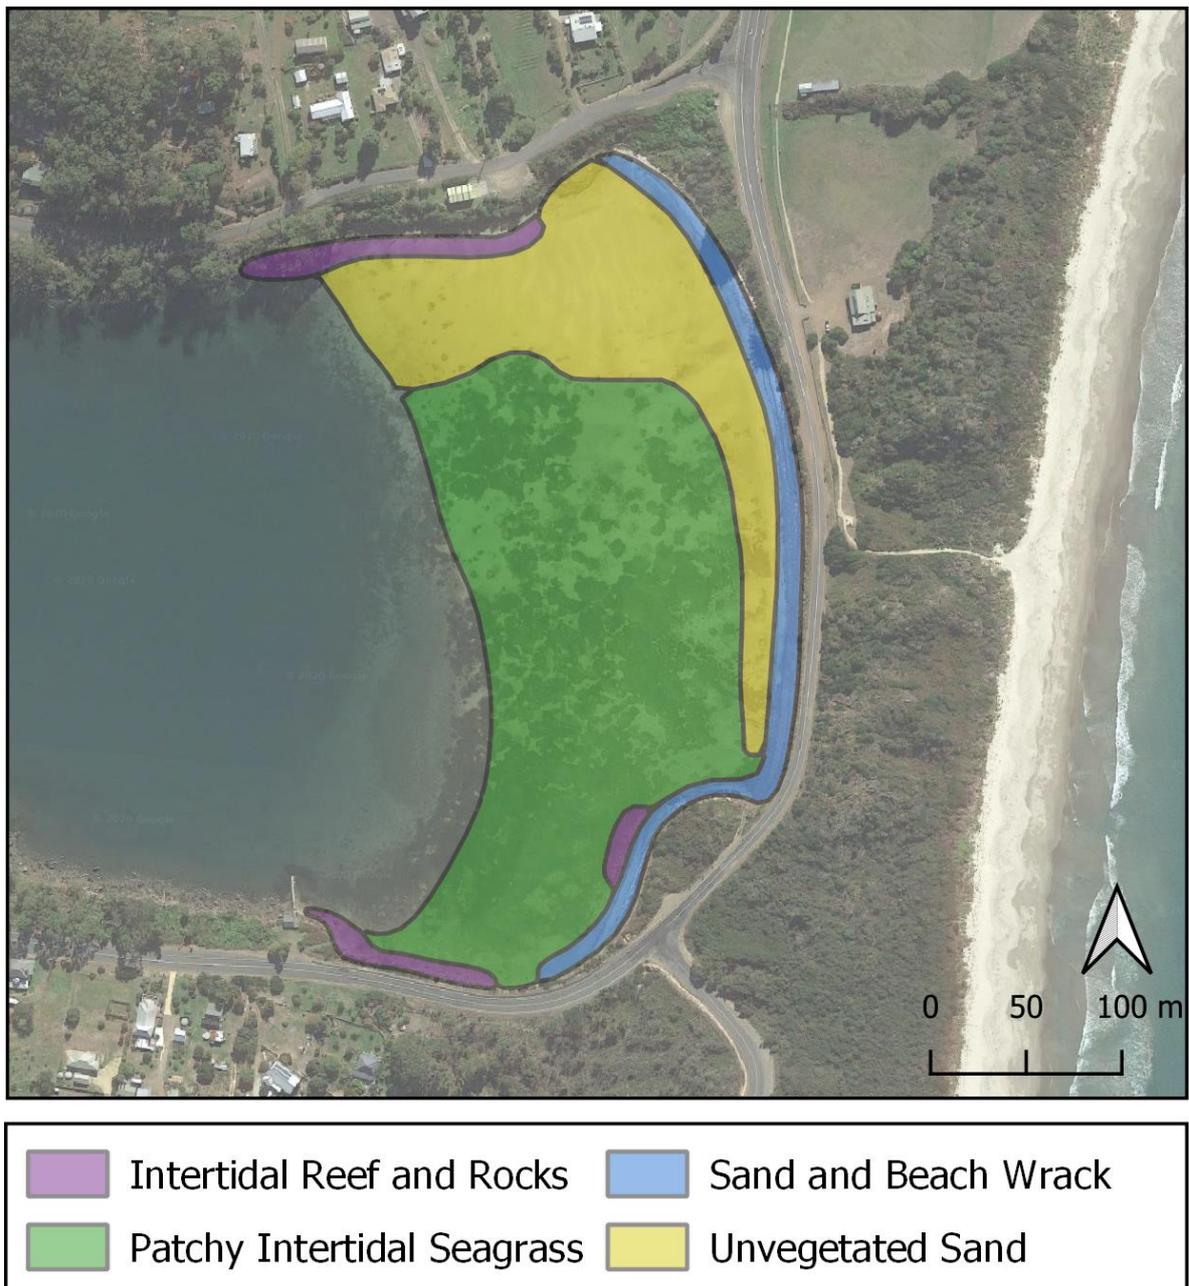
Figure 4 Marine habitats in the vicinity of Eaglehawk Bay.

Zone category	Sites	Habitat observations
Beach and upper intertidal sandflat	SU-1, SU-2, SU-3	Sandy beach and upper intertidal zone predominately coarse sand and wrack. Dead bivalve shells and seagrass most common component of beach wrack.
Mid-intertidal sandflat	SM-1, SM-2, SM-3	Sandflat with patchy seagrass (<i>Zostera muelleri</i>). Green algal epiphytes amongst seagrass assemblages. Bivalve molluscs (most common species) and gastropod molluscs commonly observed amongst seagrass and sand.
Lower intertidal sandflat	SL-1, SL-2, SL-3	Sandflat with patchy seagrass (<i>Z. muelleri</i>). Green algal epiphytes amongst seagrass assemblages. Bivalve molluscs (most common species) and gastropod molluscs commonly observed amongst seagrass and sand.
Rocky shore - south	RS-1, RS-2, RS-3	Rock wall and sparse boulders overlying sandy habitat. Patches of intertidal seagrass present. Gastropod molluscs common amongst rocky habitats, with <i>Austrocochlea constricta</i> relatively abundant. Crabs (<i>Paragrapsus gaimardii</i> and <i>Brachynotus spinosus</i>) observed beneath boulders and rocks.

Rocky shore - north	RN-1, RN-2, RN-3	Narrow fringe of rocky reef consisting mainly of boulders and rocks overlying sand. Woody debris along shoreline. Intertidal reef becoming more consolidated on the western aspect of the survey area. Gastropod molluscs were common amongst rocky habitats, with <i>A. constricta</i> relatively abundant. The most common crustaceans were porcelain crabs (<i>Petrolisthes elongatus</i>), with <i>P. gaimardii</i> and <i>B. spinosus</i> also observed.
